USAAEFA PROJECT NO. 80-13

# HISS CALIBRATION, ICE PHOBICS' AND FAA R&D EVALUATIONS

**FINAL REPORT**

**AUGUST 1981**

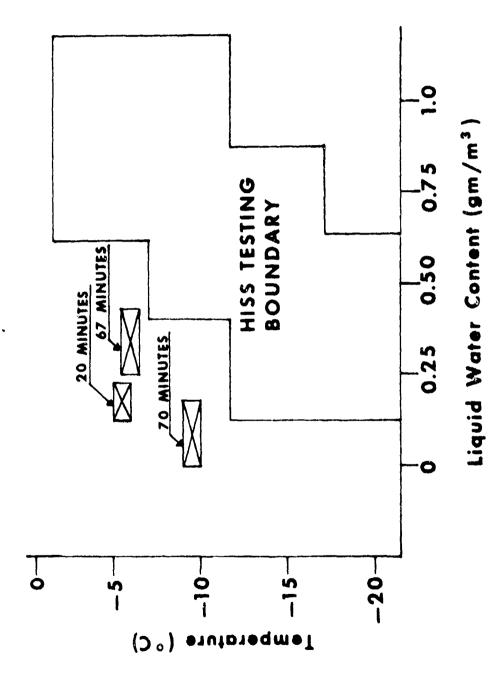
FIGURE 1. NATURAL ICING TEST CONDITIONS

- 29. Natural icing flights to verify the HISS results were flown when natural icing was present in the vicinitiy of the icing test site. The natural icing flights were in less severe conditions than any of the HISS testing; therefore, test conditions were not duplicated. Figure 1 depicts the approximate icing test conditions and HISS testing boundary. Although the natural icing results cannot be used to verify the HISS results, the two are consistent. Moderate vibrations were experienced during the 67 minute natural icing flight with clean blades at -6°C and an LWC range from approximately 0.25 to 0.50 gm/m<sup>3</sup>. Vibrations with clean blades behind the HISS were moderate during 60 minutes at -5°C and 0.75 gm/m<sup>3</sup> LWC and at the lower end of the severe range after approximately 21 at -10°C and 0.50 gm/m<sup>3</sup> LWC. Light vibrations were noted during the 70 minute natural icing flight with coated blades at -9°C and less than 0.25 gm/m³ LWC. Vibrations with coated blades behind the HISS were moderate during 60 minutes at -15°C and 0.25 gm/m³ LWC and severe during 60 minutes at -10°C and 0.50 gm/m³ LWC. No vibrations were noted during the 20 minute natural icing flight with clean blades at -5°C and less than 0.25 gm/m<sup>3</sup> LWC. The only significant increase in power required noted during the natural icing flights was during the 67 minute flight with clean blades at -6°C and an LWC range from approximately 0.25 to 0.50 gm/m<sup>3</sup>. Although the exact magnitude of the increase was not determined because a portion occurred due to ice accretion during the climb to test altitude, the increase required a reduction of cruise airspeed from 90 KIAS to 70 KIAS. Power increases exceeding 5 psi torque were noted with clean blades behind the HISS during 60 minutes at -5°C and 0.75 gm/m<sup>3</sup> LWC and -10°C and 0.50 gm/m<sup>3</sup> LWC. Autorotative rpm was not checked during the natural icing flights.

- 30. The natural icing flights were alternately flown with electric heat off for the pilot's or copilot's windshield to evaluate the capability of the aircraft heating and ventilating system to keep the windshields free of ice. No ice accretion was noted on either windshield during the natural icing flights; however, ice might have accreted during more severe conditions.

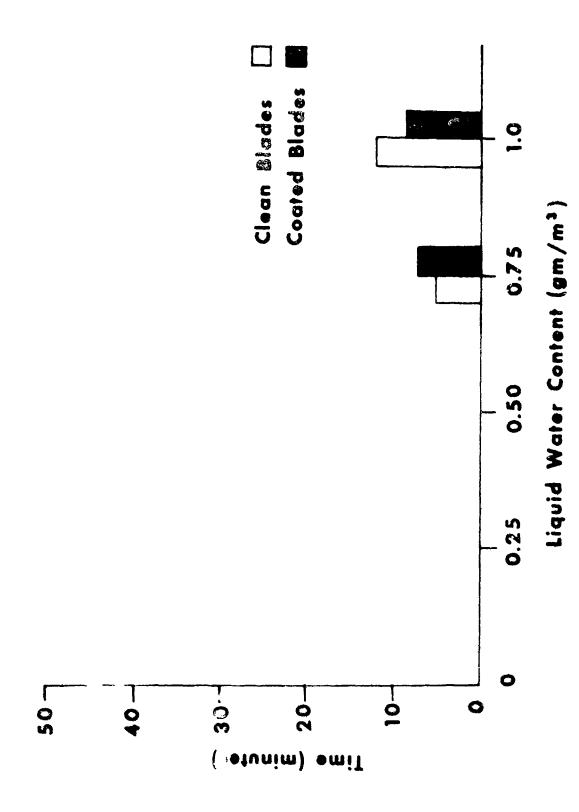
TIME TO FIRST MODERATE VIBRATION AT -5°C FIGURE 3.

- 21. Immersion times in the HISS cloud until the first moderate vibration and the first severe vibration are presented in figures 3 through 8, appendix E. Comparisons of these times shows that the coated blades were slightly inferier to the clean blades. Comparing times until the first moderate vibration: the coated blades were inferior for five of the test conditions, superior for two of the test conditions, while there was essentially no difference between coated and clean at one test condition. In the comparison of times until the first severe vibration, the coated blades were inferior for four test conditions and superior for three test conditions, while a moderate vibration was the worst experienced with either at one test condition.

- 36. No further testing of the G661 ice phobic compound is recommended (par 24).
- 37. Prolonged flight (over 10-15 minutes) into light icing is not recommded (par 32).
- 38. Flight in the UH-1H into moderate or higher intensity icing should be prohibited (par 32).
- 39. Icing severity level indication system for the UH-1H in order to utilize the aircraft to its fullest potential.
